Proposed Subdivision
Brush Creek Estate -
Stage 4
Site Classification

Transfield Avenue,
Edgeworth

NEW18P-0170-AG
13 December 2019

**RE: PROPOSED SUBDIVISION – BRUSH CREEK ESTATE – STAGE 4
TRANSFIELD AVENUE, EDGEWORTH
SITE CLASSIFICATION (LOTS 401 TO 409)**

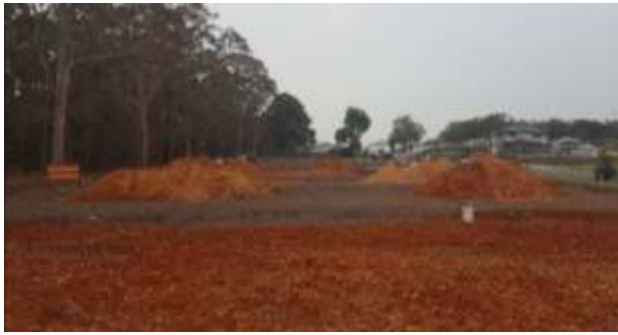
Photograph 1: Facing south from near TP401. Tree mulch stockpiles on Lots 405 to 407.
