Proposed Subdivision
Brush Creek Estate -
Precinct 2, Stage 6B
Site Classification

Watalong Way,
Edgeworth

NEW18P-0170C-AD
1 September 2022

**RE: PROPOSED SUBDIVISION - BRUSH CREEK ESTATE – PRECINCT 2, STAGE 6B
WATALONG WAY, EDGEWORTH
SITE CLASSIFICATION TO AS2870-2011 (LOTS 617 TO 626)**

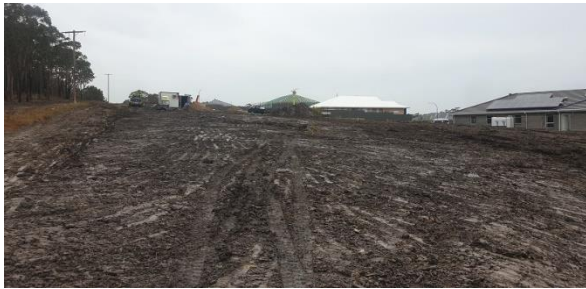
Photograph 1: From near north-western corner of Lot 617, facing southeast.

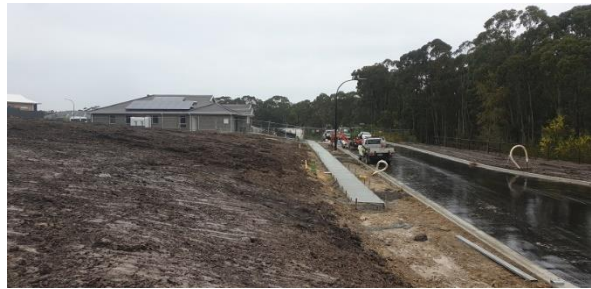
Photograph 2: From near north-western corner of Lot 617, facing south.

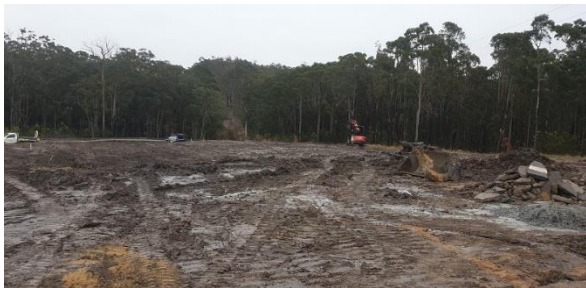
Photograph 3: From near shared boundary of Lots 620 and 621, facing west.

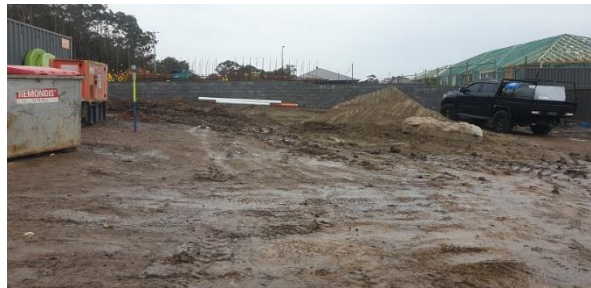
Photograph 4: From near shared boundary of Lots 620 and 621, facing east.

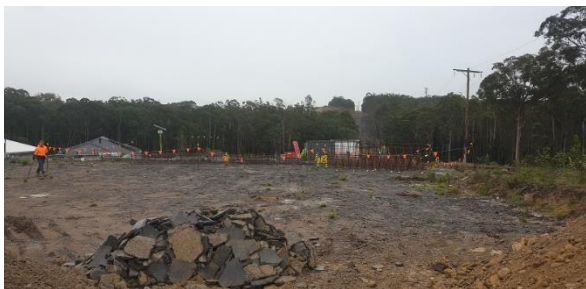
Photograph 5: From eastern boundary of Lot 623, facing west.

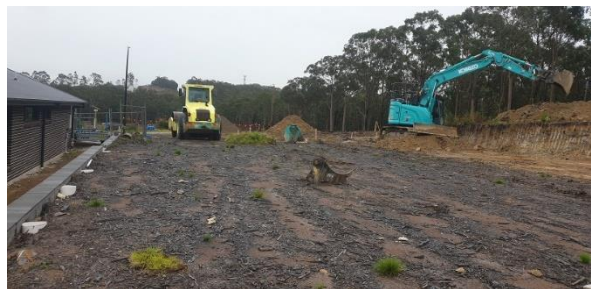
Photograph 6: From eastern boundary of Lot 624, facing west.

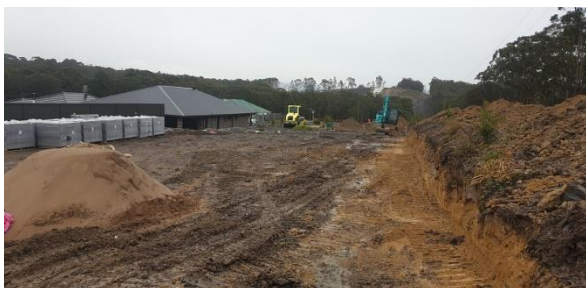
Photograph 7: From north-eastern corner of Lot 625, facing west.

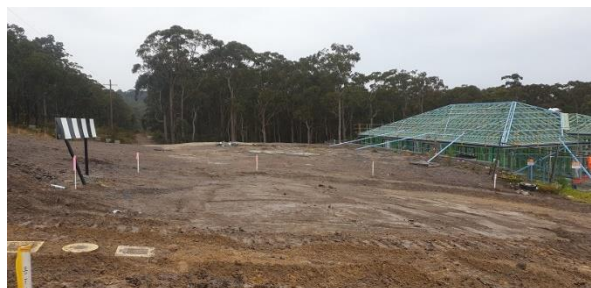
Photograph 8: From north-eastern corner of Lot 625, facing east. Lot 626 in background.
