BUSHFIRE ATTACK LEVEL

FOR FUTURE DWELLINGS

AT STAGE I BRUSH CREEK, EDGEWORTH NSW

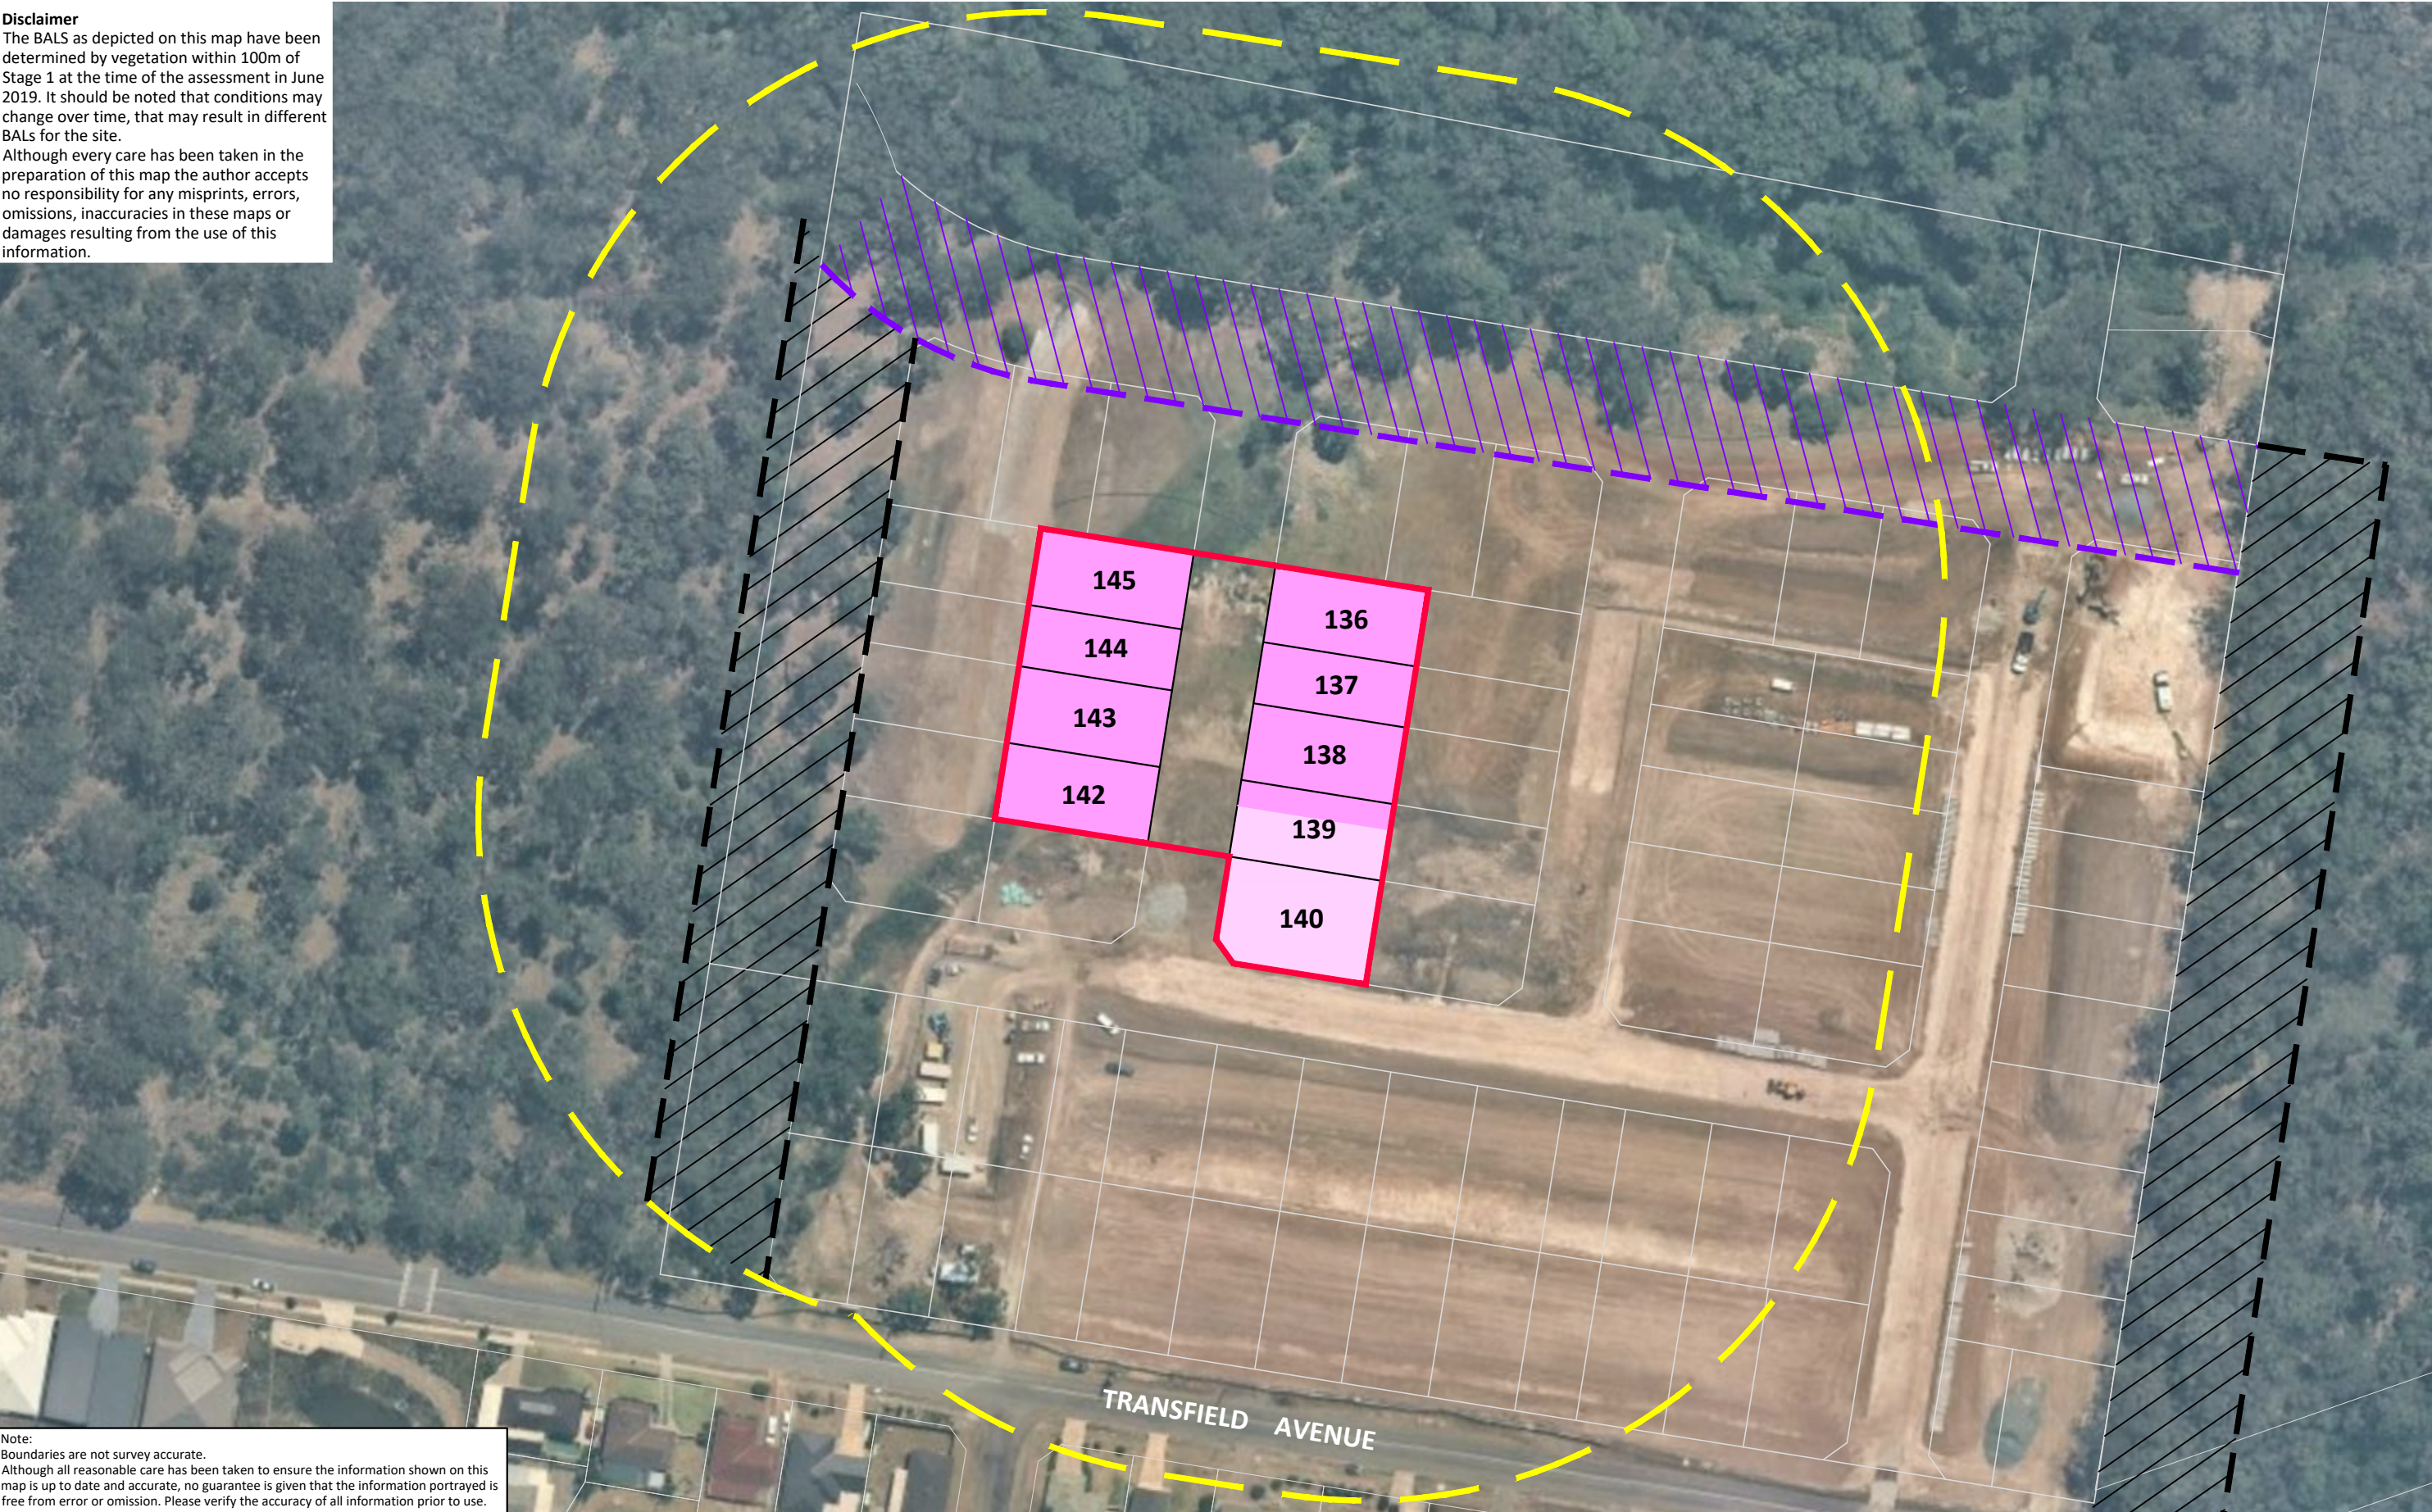
FIGURE 5-1: BUSHFIRE ATTACK LEVELS MAP

- Subject Site
- 100m Buffer
- 25m APZ
- Temporary 25m APZ
- BAL 12.5
- BAL Low
