Proposed Subdivision
Brush Creek Estate -
Stage 1
Site Classification

Transfield Avenue,
Edgeworth

NEW18P-0170-AD.Rev1
28 August 2019

**RE: PROPOSED SUBDIVISION – BRUSH CREEK ESTATE – STAGE 1
TRANSFIELD AVENUE, EDGEWORTH
SITE CLASSIFICATION (LOTS 101 TO 145)**

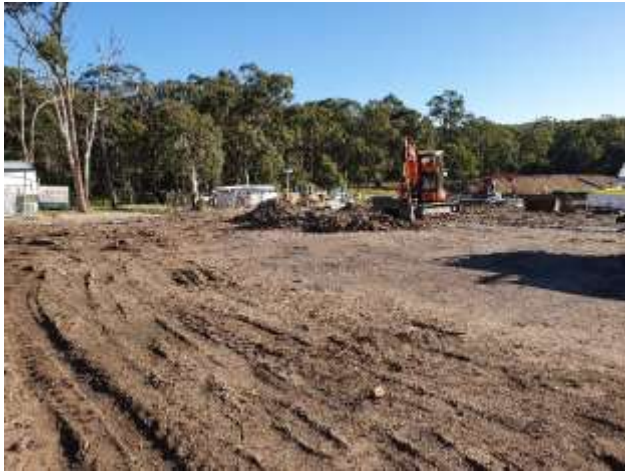
Photograph 1: Facing northwest from near south-eastern corner of Lot 109. Showing excavator at TP001.

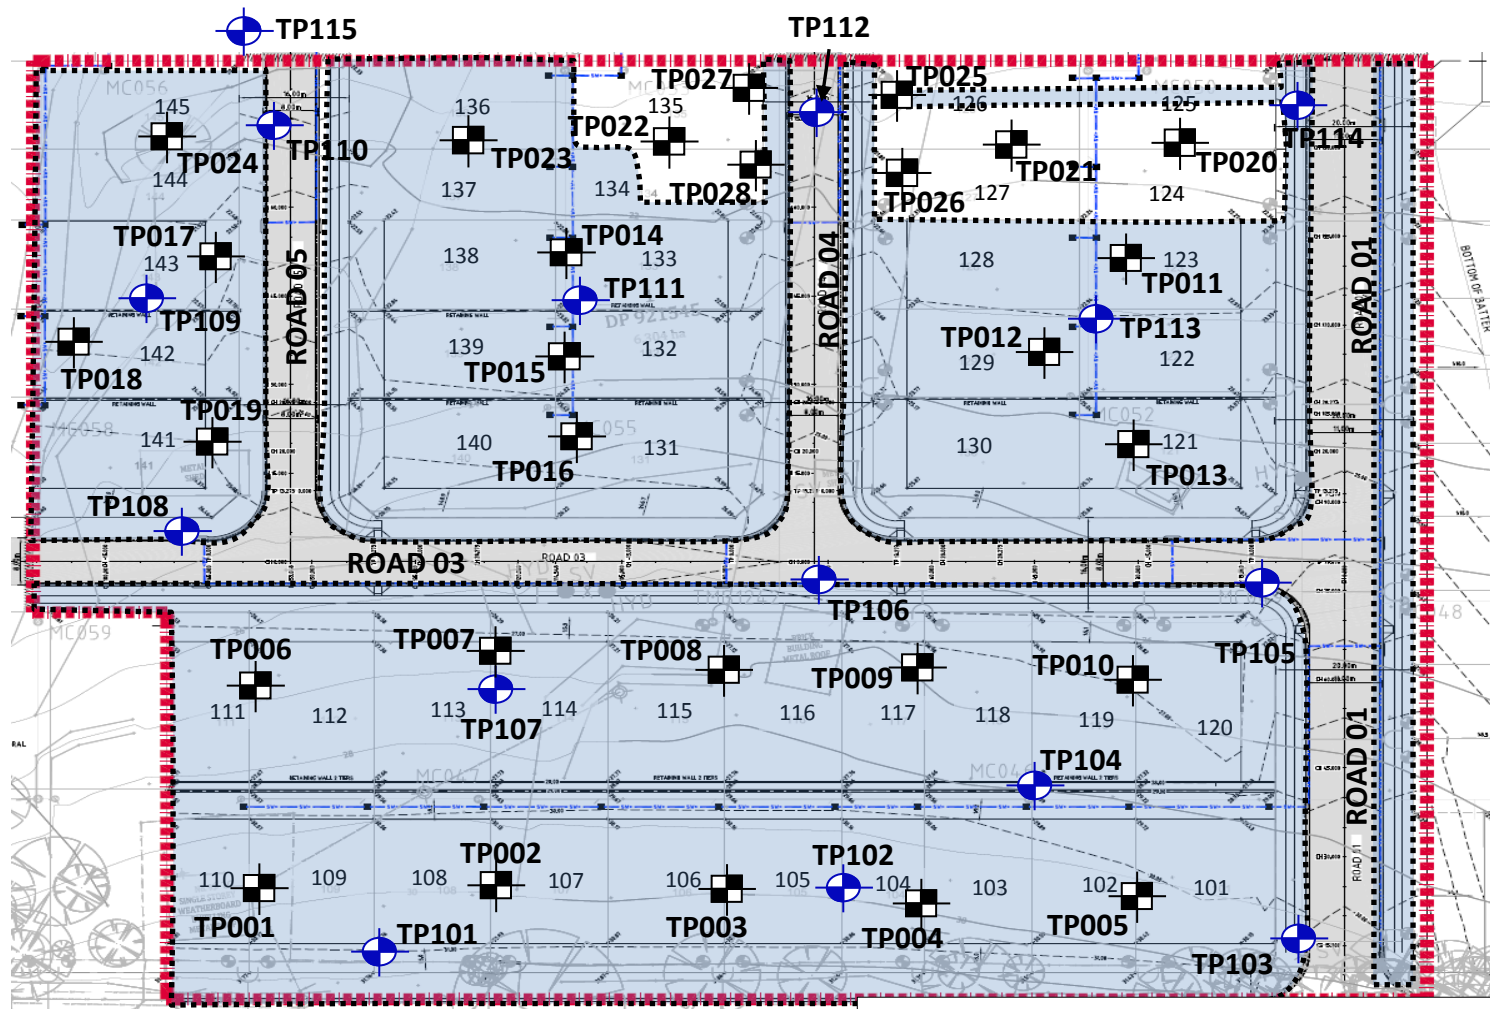
FIGURE AD1

Site Plan and Approximate Test Locations

Based on the results of the field work, laboratory testing and site regrade works conducted, residential lots located within Stage 1 of the Brush Creek Estate residential subdivision, as shown on the attached Figure AD1, are classified in their current condition in accordance with AS2870-2011 'Residential Slabs and Footings', as shown in Table 4.

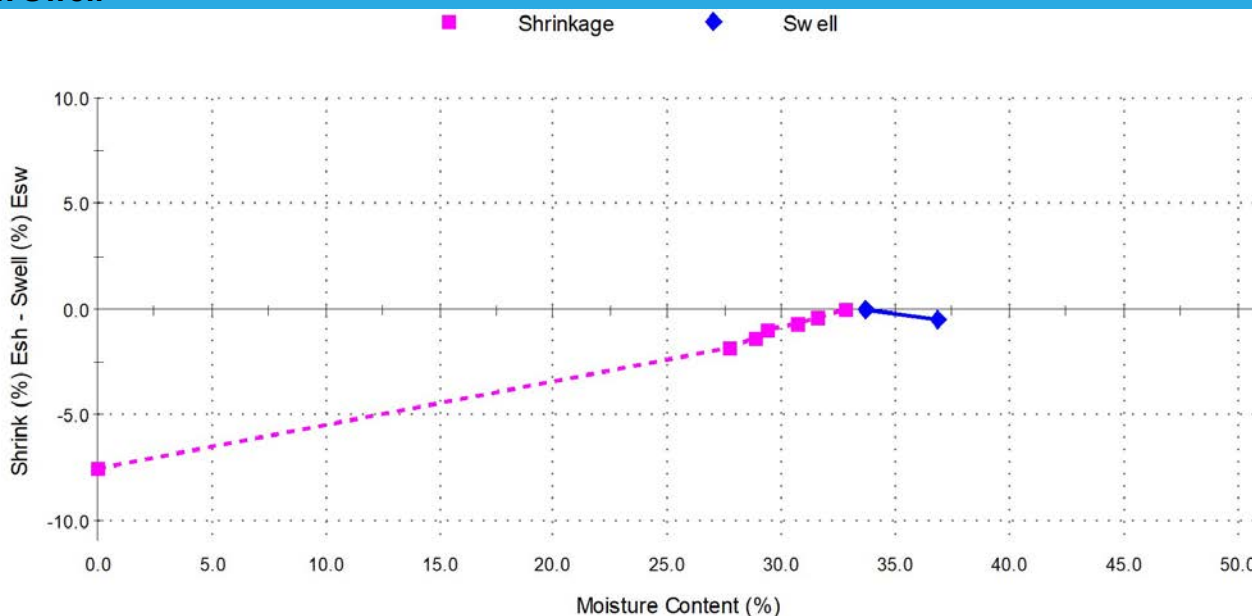
Shrink Swell

Shrink Swell Index - Iss (%): 4.2

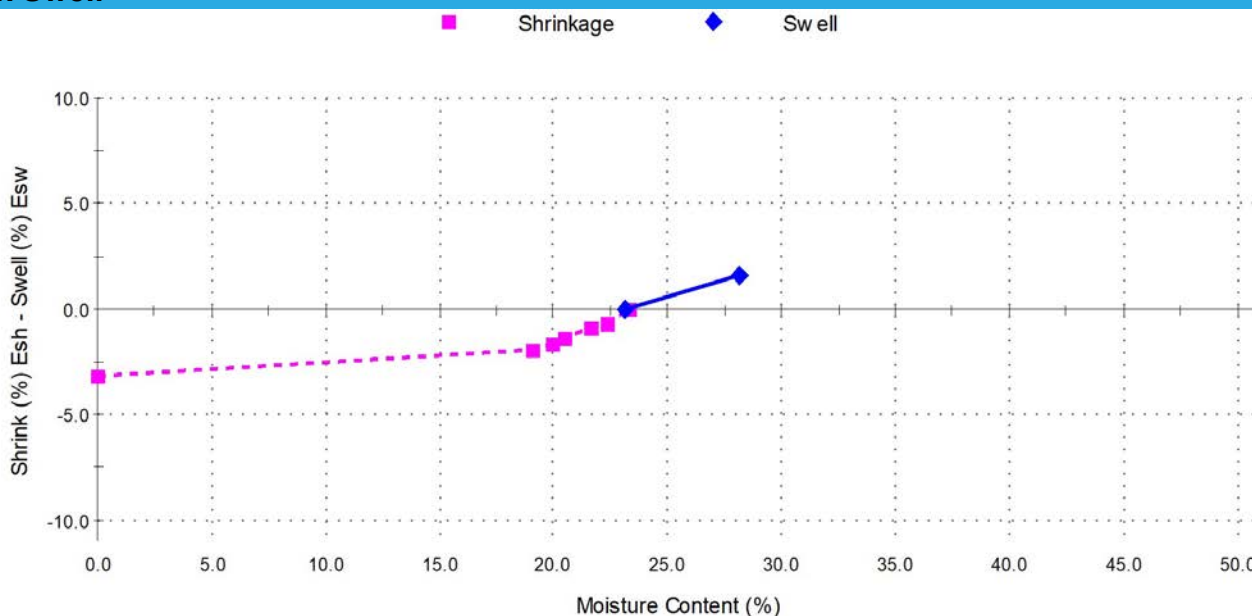
Shrink Swell

Shrink Swell Index - Iss (%): 2.2

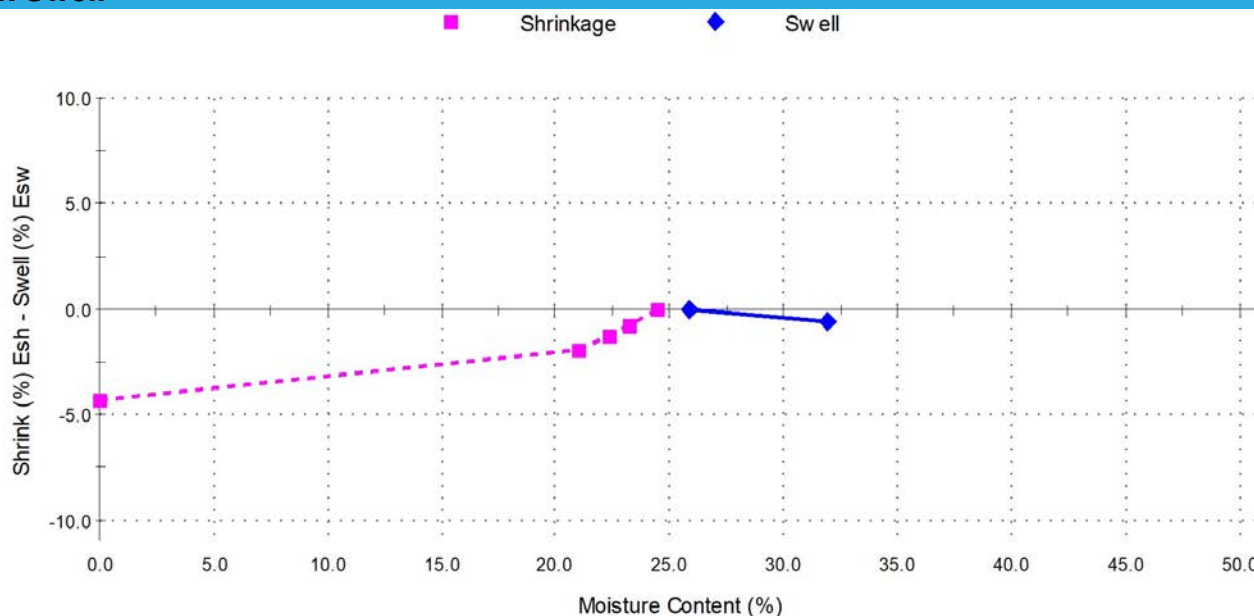
Shrink Swell

Shrink Swell Index - Iss (%): 2.4
