Proposed Subdivision
Brush Creek Estate -
Precinct 2, Stage 5
Site Classification

Transfield Avenue,
Edgeworth

NEW18P-0170B-AC
19 January 2021

**RE: PROPOSED SUBDIVISION - BRUSH CREEK ESTATE – PRECINCT 2, STAGE 5
TRANSFIELD AVENUE, EDGEWORTH
GEOTECHNICAL ASSESSMENT**

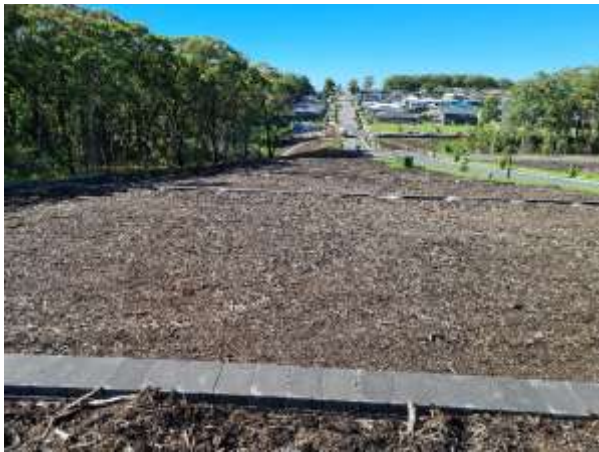
Photograph 1: From near BH505, facing southwest.

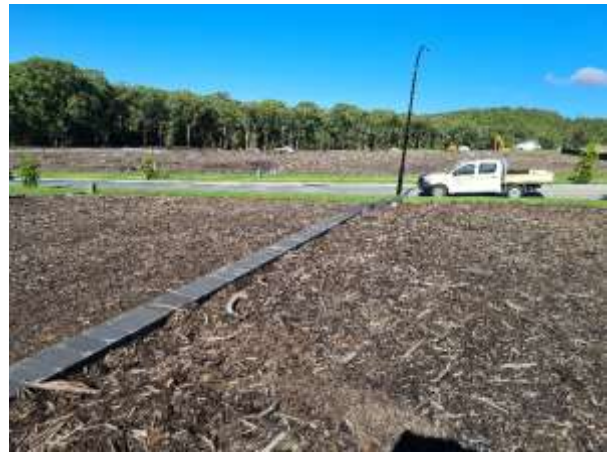
Photograph 2: From near BH505, facing west.

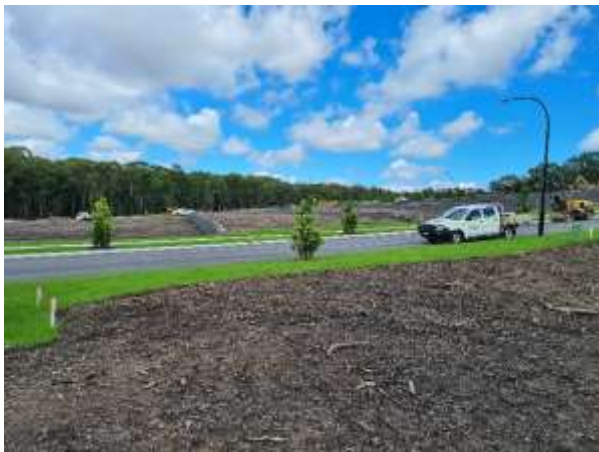
Photograph 3: From near BH501, facing northwest.

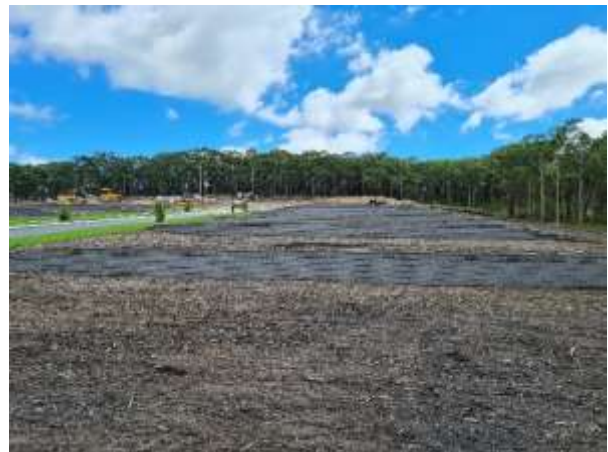
Photograph 4: From near BH501, facing north.

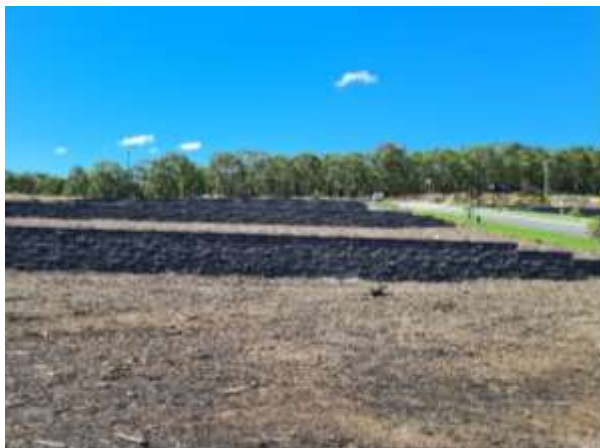
Photograph 5: From near BH523, facing northeast.

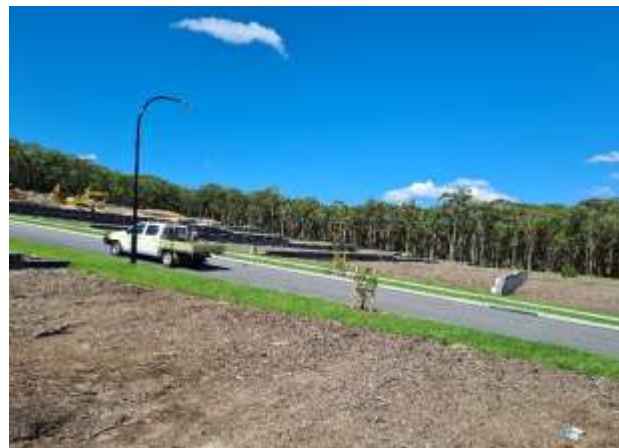
Photograph 6: From near BH523, facing east.

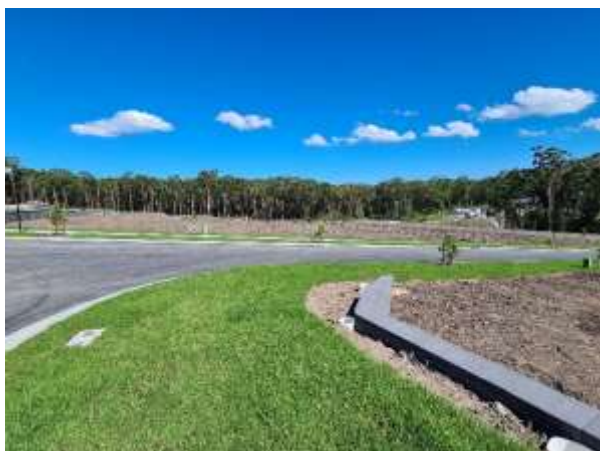
Photograph 7: From near northern boundary of Lot 521, facing southeast.

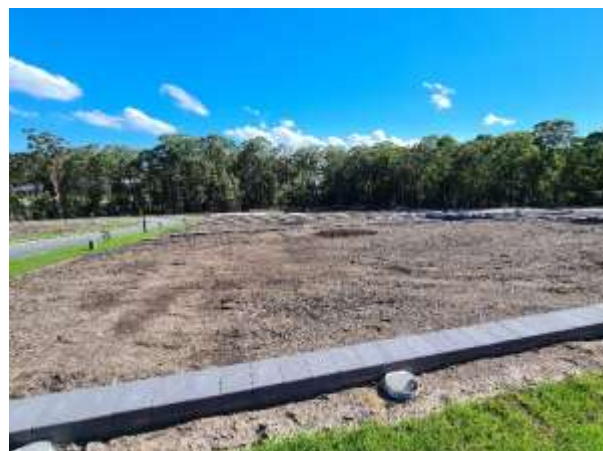
Photograph 8: From near northern boundary of Lot 521, facing southwest.
