Proposed Subdivision
Brush Creek Estate -
Precinct 2, Stage 1
Site Classification

Bootaring Boulevard,
Edgeworth

NEW18P-0170D-AC
14 October 2021

**RE: PROPOSED SUBDIVISION - BRUSH CREEK ESTATE – PRECINCT 2, STAGE 1
BOOTARING BOULEVARD, EDGEWORTH
SITE CLASSIFICATION (LOTS 101 TO 133)**

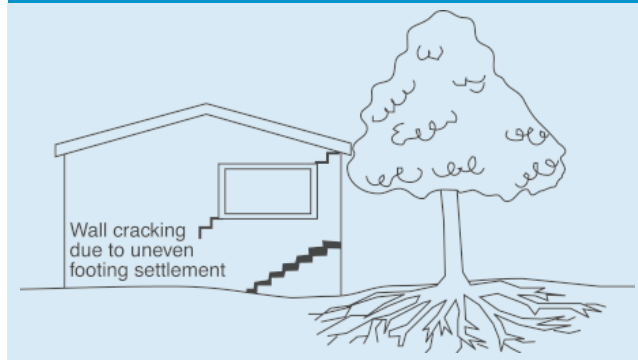
As the moisture absorption process completes its journey to the innermost areas of the building, the internal footings will rise. If the spread of moisture is roughly even, it may be that the symptoms will temporarily disappear, but it is more likely that swelling will be uneven, creating a difference rather than a disappearance in symptoms. In buildings with timber flooring supported by bearers and joists, the isolated piers will rise more easily than the strip footings or piers under walls, creating noticeable doming of flooring.

Trees can cause shrinkage and damage

As the weather pattern changes and the soil begins to dry out, the external footings will be first affected, beginning with the locations where the sun's effect is strongest. This has the effect of lowering the external footings. The doming is accentuated and cracking reduces or disappears where it occurred because of dishing, but other cracks open up. The roof lines may become convex.
