Proposed Subdivision  
Brush Creek Estate -  
Precinct 2, Stage 7  
Site Classification

Kenakan Street,  
Edgeworth

NEW18P-0170I-AB  
7 February 2023

**RE: PROPOSED SUBDIVISION - BRUSH CREEK ESTATE – PRECINCT 2, STAGE 7  
KENAKAN STREET, EDGEWORTH  
SITE CLASSIFICATION TO AS2870-2011 (LOTS 701 TO 724)**

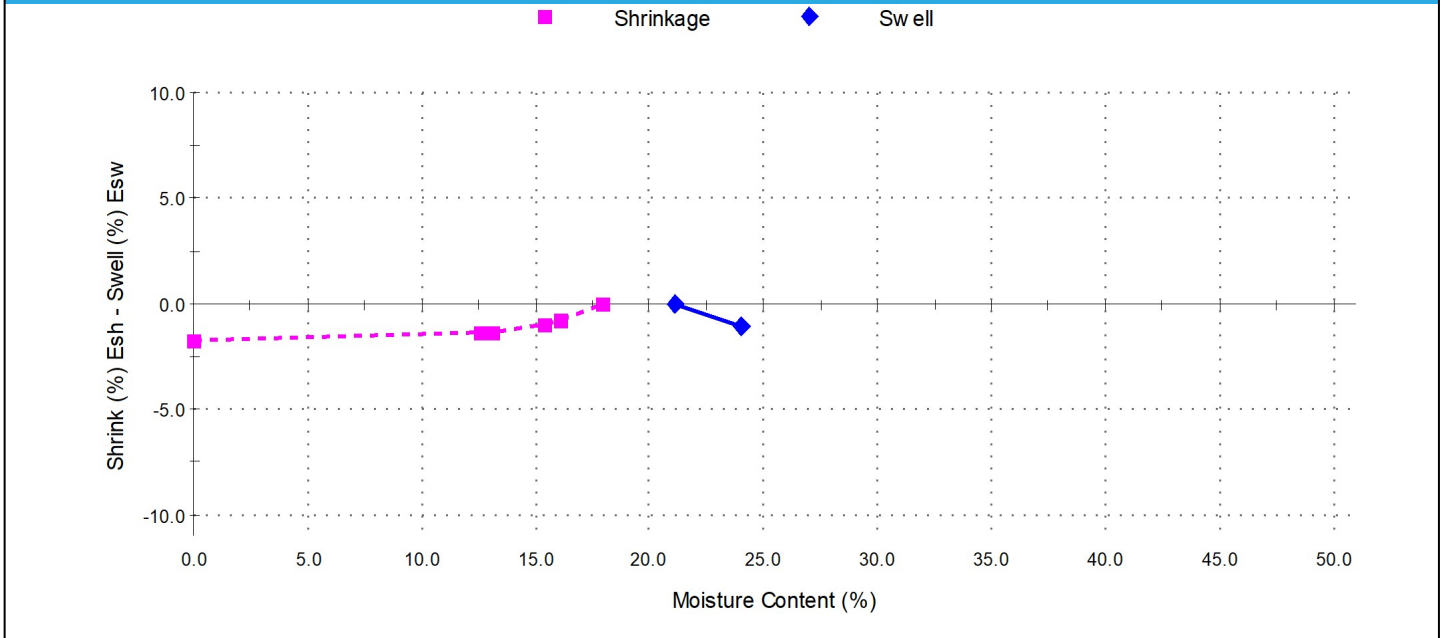
## Shrink Swell

Swell Test AS 1289.7.1.1		Shrink Test AS 1289.7.1.1	
<b>Swell on Saturation (%):</b>	-1.1	<b>Shrink on drying (%):</b>	1.7
<b>Moisture Content before (%):</b>	21.1	<b>Shrinkage Moisture Content (%):</b>	17.9
<b>Moisture Content after (%):</b>	24.0	<b>Est. inert material (%):</b>	2%
<b>Est. Unc. Comp. Strength before (kPa):</b>	450	<b>Crumbling during shrinkage:</b>	Nil
<b>Est. Unc. Comp. Strength after (kPa):</b>	240	<b>Cracking during shrinkage:</b>	Moderate

**Shrink Swell Index - Iss (%): 0.9**

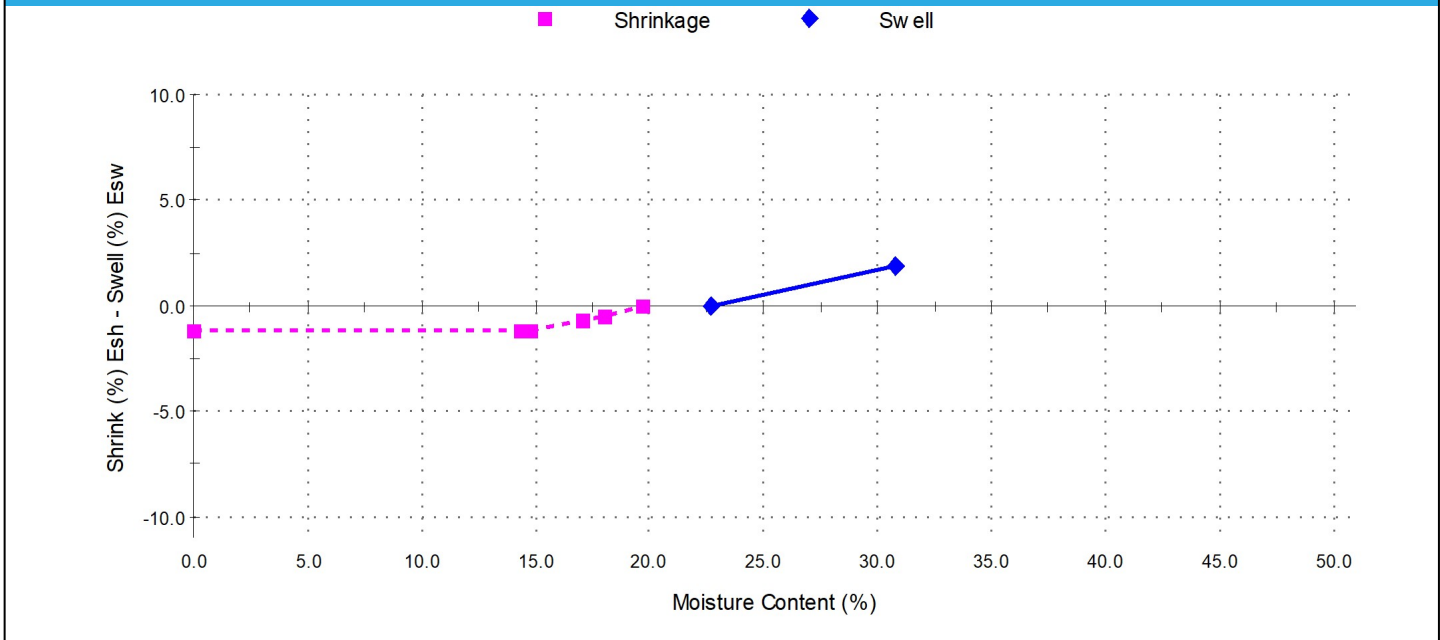
## Shrink Swell

Swell Test AS 1289.7.1.1		Shrink Test AS 1289.7.1.1	
<b>Swell on Saturation (%):</b>	1.9	<b>Shrink on drying (%):</b>	1.2
<b>Moisture Content before (%):</b>	22.7	<b>Shrinkage Moisture Content (%):</b>	19.7
<b>Moisture Content after (%):</b>	30.8	<b>Est. inert material (%):</b>	2%
<b>Est. Unc. Comp. Strength before (kPa):</b>	570	<b>Crumbling during shrinkage:</b>	Nil
<b>Est. Unc. Comp. Strength after (kPa):</b>	300	<b>Cracking during shrinkage:</b>	Major

**Shrink Swell Index - Iss (%): 1.2**

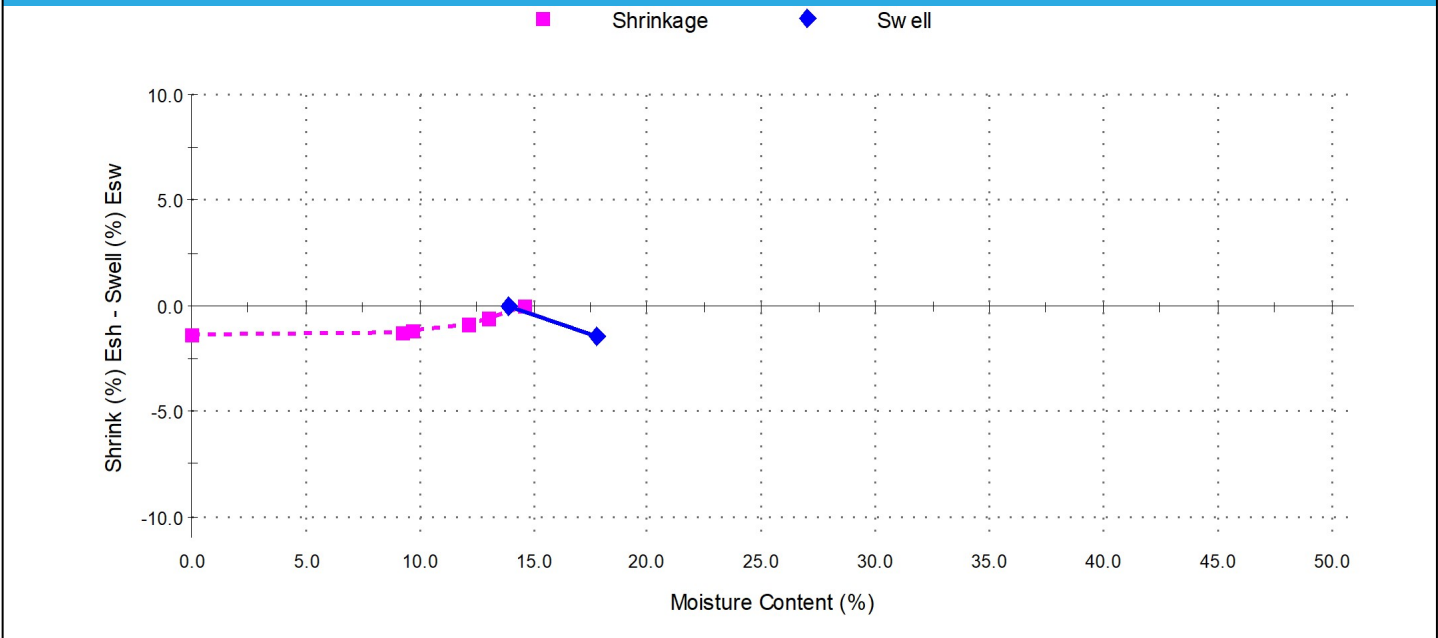
## Shrink Swell

Swell Test AS 1289.7.1.1		Shrink Test AS 1289.7.1.1	
<b>Swell on Saturation (%):</b>	-1.4	<b>Shrink on drying (%):</b>	1.4
<b>Moisture Content before (%):</b>	13.9	<b>Shrinkage Moisture Content (%):</b>	14.6
<b>Moisture Content after (%):</b>	17.7	<b>Est. inert material (%):</b>	3%
<b>Est. Unc. Comp. Strength before (kPa):</b>	>600	<b>Crumbling during shrinkage:</b>	Nil
<b>Est. Unc. Comp. Strength after (kPa):</b>	>600	<b>Cracking during shrinkage:</b>	Minor

**Shrink Swell Index - Iss (%): 0.8**

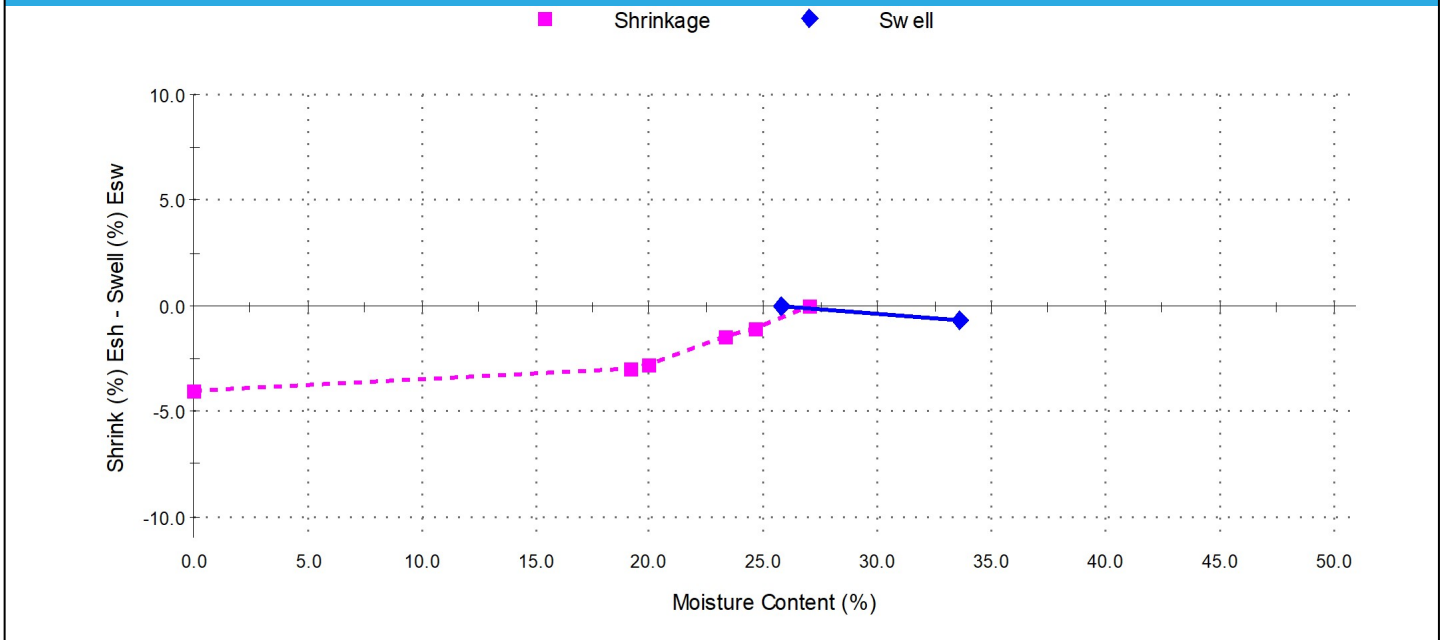
## Shrink Swell

Swell Test AS 1289.7.1.1		Shrink Test AS 1289.7.1.1	
<b>Swell on Saturation (%):</b>	-0.7	<b>Shrink on drying (%):</b>	4.0
<b>Moisture Content before (%):</b>	25.8	<b>Shrinkage Moisture Content (%):</b>	27.0
<b>Moisture Content after (%):</b>	33.6	<b>Est. inert material (%):</b>	4%
<b>Est. Unc. Comp. Strength before (kPa):</b>	340	<b>Crumbling during shrinkage:</b>	Nil
<b>Est. Unc. Comp. Strength after (kPa):</b>	370	<b>Cracking during shrinkage:</b>	Minor

**Shrink Swell Index - Iss (%): 2.2**

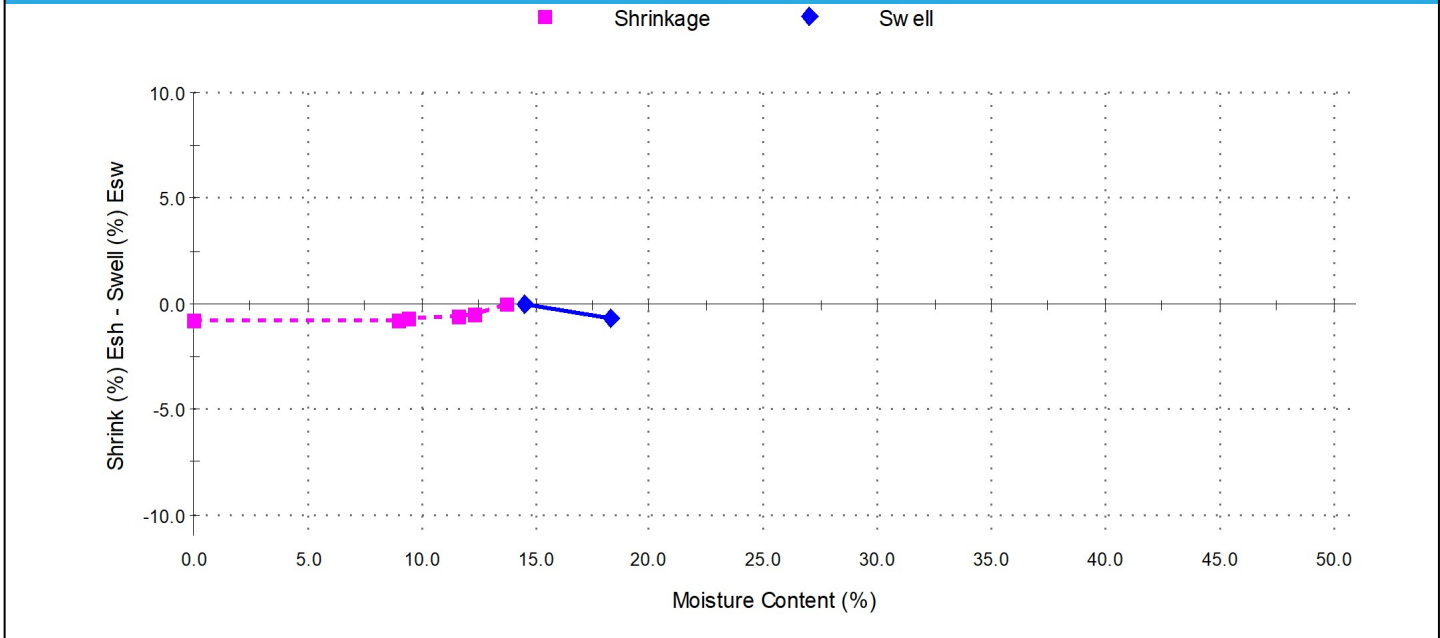
## Shrink Swell

Swell Test AS 1289.7.1.1		Shrink Test AS 1289.7.1.1	
<b>Swell on Saturation (%):</b>	-0.7	<b>Shrink on drying (%):</b>	0.8
<b>Moisture Content before (%):</b>	14.6	<b>Shrinkage Moisture Content (%):</b>	13.7
<b>Moisture Content after (%):</b>	18.3	<b>Est. inert material (%):</b>	3%
<b>Est. Unc. Comp. Strength before (kPa):</b>	560	<b>Crumbling during shrinkage:</b>	Nil
<b>Est. Unc. Comp. Strength after (kPa):</b>	280	<b>Cracking during shrinkage:</b>	Minor

**Shrink Swell Index - Iss (%): 0.4**

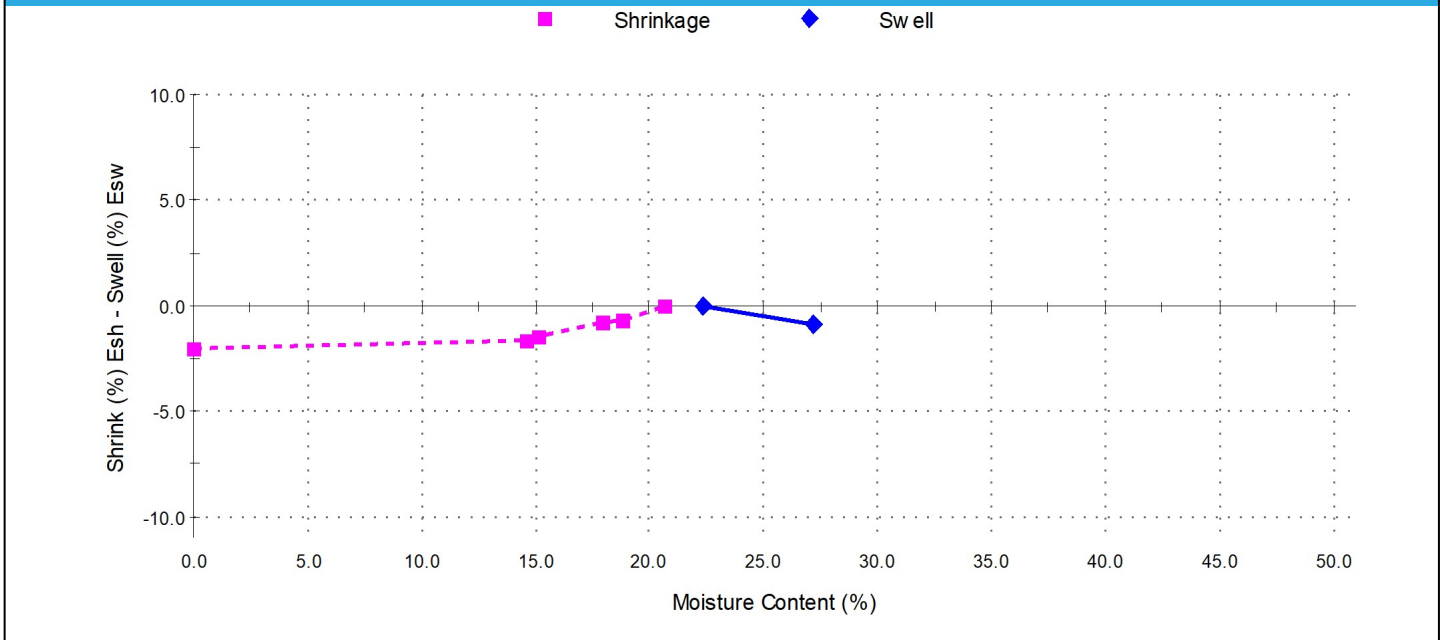
## Shrink Swell

Swell Test AS 1289.7.1.1		Shrink Test AS 1289.7.1.1	
<b>Swell on Saturation (%):</b>	-0.9	<b>Shrink on drying (%):</b>	2.0
<b>Moisture Content before (%):</b>	22.3	<b>Shrinkage Moisture Content (%):</b>	20.7
<b>Moisture Content after (%):</b>	27.2	<b>Est. inert material (%):</b>	3%
<b>Est. Unc. Comp. Strength before (kPa):</b>	260	<b>Crumbling during shrinkage:</b>	Nil
<b>Est. Unc. Comp. Strength after (kPa):</b>	270	<b>Cracking during shrinkage:</b>	Moderate

**Shrink Swell Index - Iss (%): 1.1**

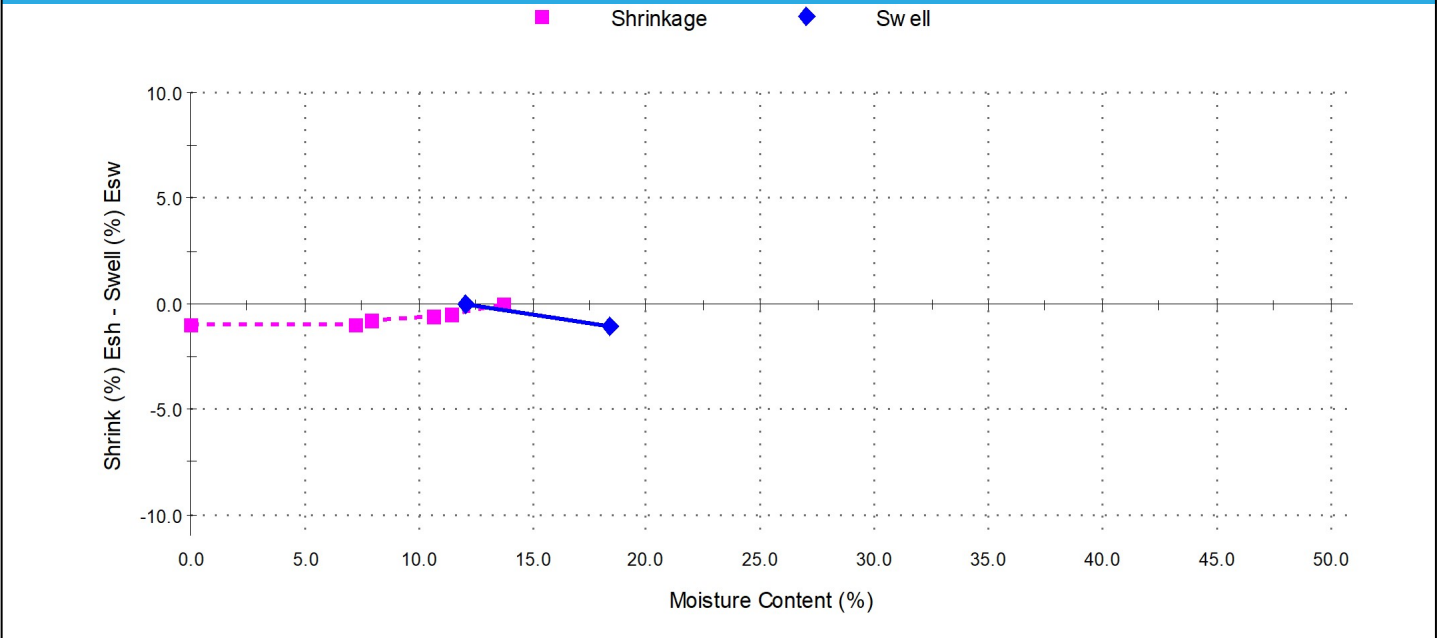
## Shrink Swell

Swell Test AS 1289.7.1.1		Shrink Test AS 1289.7.1.1	
<b>Swell on Saturation (%):</b>	-1.0	<b>Shrink on drying (%):</b>	1.0
<b>Moisture Content before (%):</b>	12.1	<b>Shrinkage Moisture Content (%):</b>	13.7
<b>Moisture Content after (%):</b>	18.4	<b>Est. inert material (%):</b>	2%
<b>Est. Unc. Comp. Strength before (kPa):</b>	490	<b>Crumbling during shrinkage:</b>	Nil
<b>Est. Unc. Comp. Strength after (kPa):</b>	500	<b>Cracking during shrinkage:</b>	Minor

**Shrink Swell Index - Iss (%): 0.6**

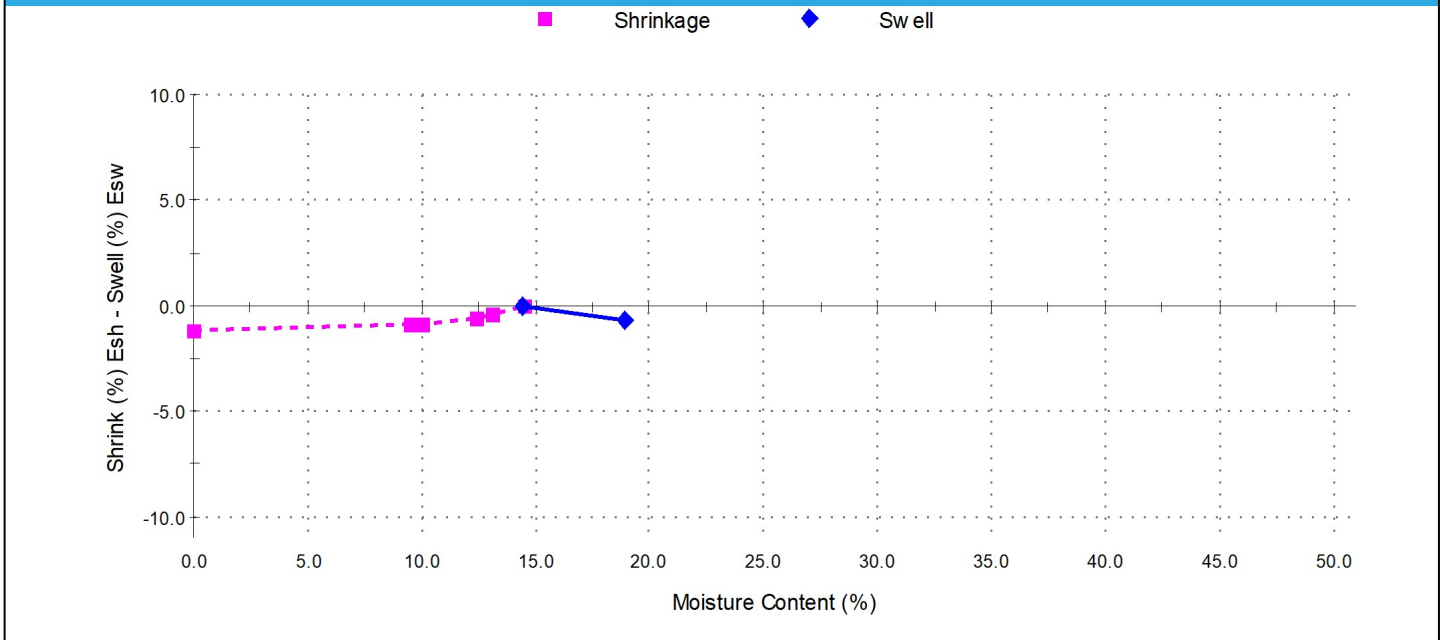
## Shrink Swell

Swell Test AS 1289.7.1.1		Shrink Test AS 1289.7.1.1	
<b>Swell on Saturation (%):</b>	-0.7	<b>Shrink on drying (%):</b>	1.2
<b>Moisture Content before (%):</b>	14.4	<b>Shrinkage Moisture Content (%):</b>	14.5
<b>Moisture Content after (%):</b>	18.9	<b>Est. inert material (%):</b>	1%
<b>Est. Unc. Comp. Strength before (kPa):</b>	>600	<b>Crumbling during shrinkage:</b>	Nil
<b>Est. Unc. Comp. Strength after (kPa):</b>	>600	<b>Cracking during shrinkage:</b>	Minor

**Shrink Swell Index - Iss (%): 0.6**

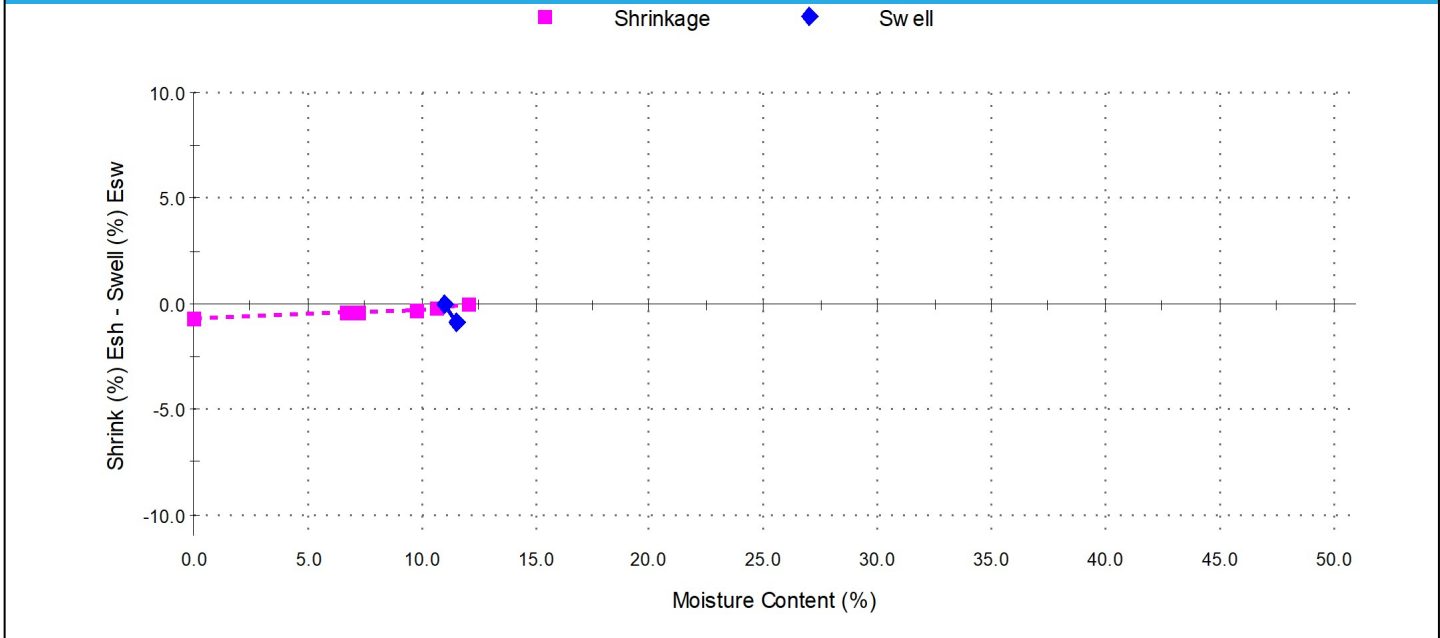
## Shrink Swell

Swell Test AS 1289.7.1.1		Shrink Test AS 1289.7.1.1	
<b>Swell on Saturation (%):</b>	-0.8	<b>Shrink on drying (%):</b>	0.7
<b>Moisture Content before (%):</b>	11.0	<b>Shrinkage Moisture Content (%):</b>	12.1
<b>Moisture Content after (%):</b>	11.5	<b>Est. inert material (%):</b>	2%
<b>Est. Unc. Comp. Strength before (kPa):</b>	160	<b>Crumbling during shrinkage:</b>	Nil
<b>Est. Unc. Comp. Strength after (kPa):</b>	>600	<b>Cracking during shrinkage:</b>	Nil

**Shrink Swell Index - Iss (%): 0.4**
