# **BUSHFIRE ATTACK LEVEL**

## **FOR FUTURE DWELLINGS**

### **AT STAGE 4 BRUSH CREEK EDGEWORTH**

**Firebird ecoSultants Pty Ltd**

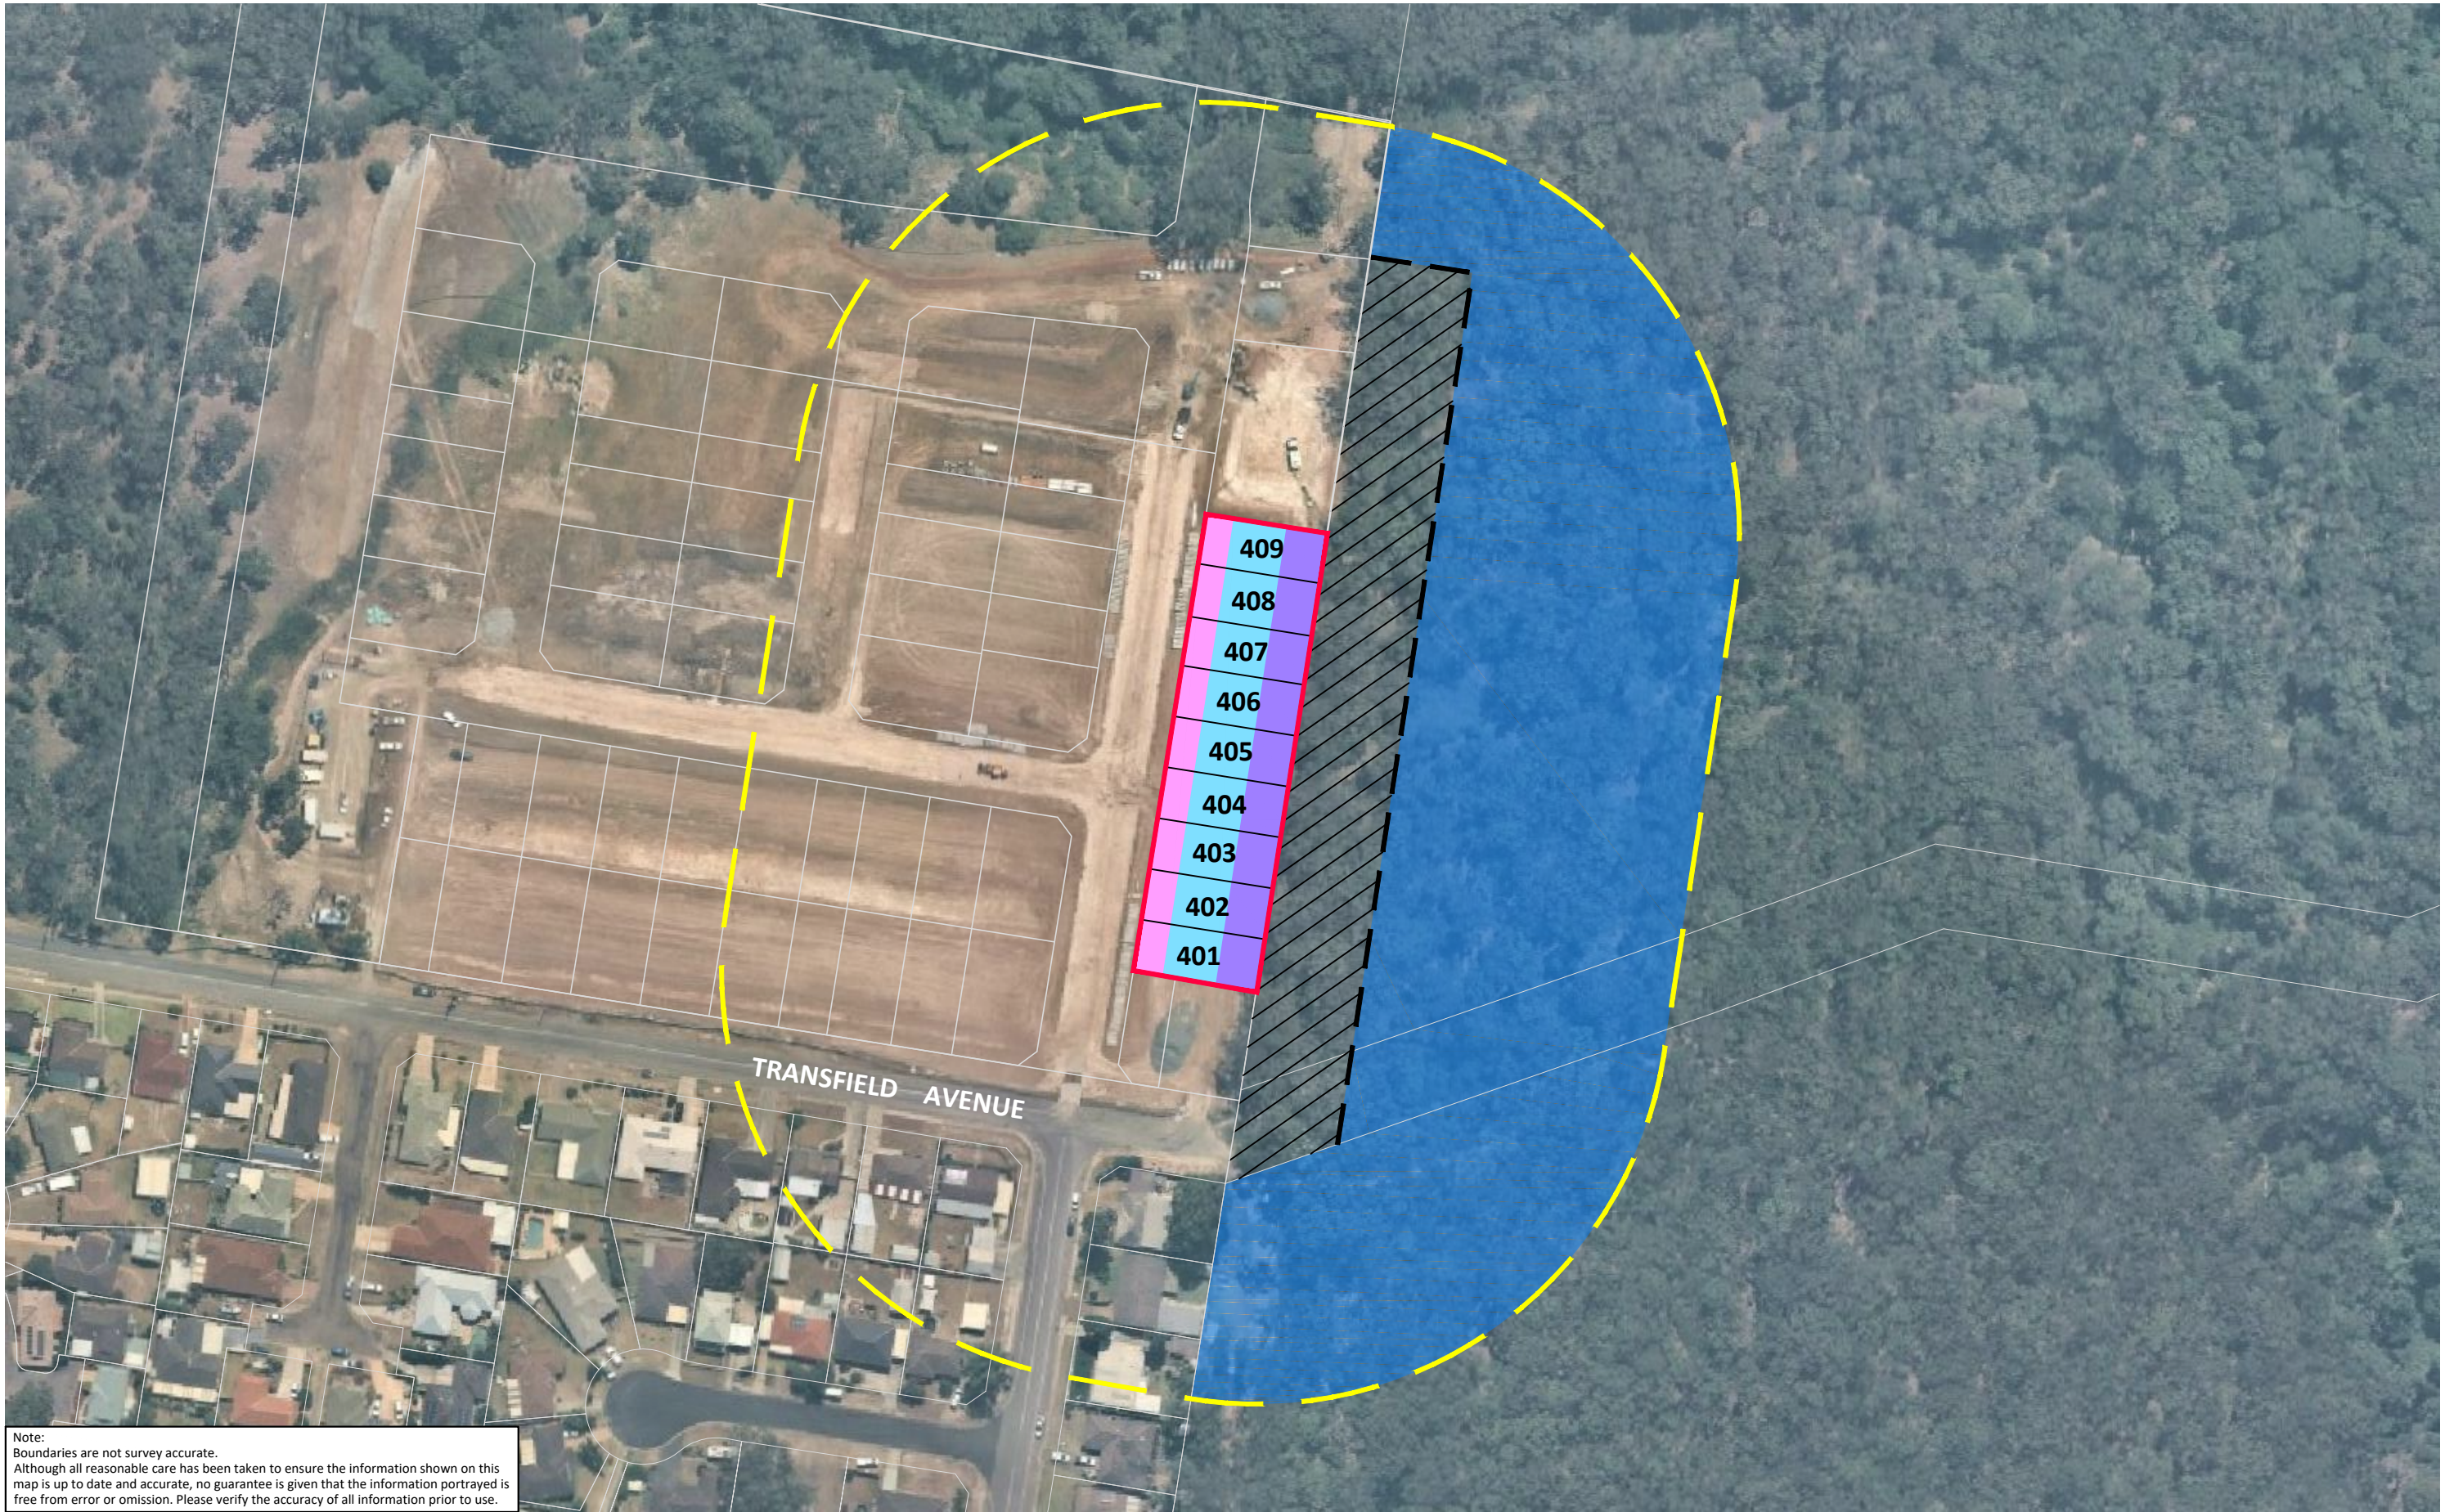
FIGURE 5-1: BUSHFIRE ATTACK LEVELS MAP

The results from this bush fire attack assessment are detailed below in Table 4-1– Bushfire Attack Level (BAL) Assessment and Figure 4-1 Bushfire Attack Level Map.

Lot Number	Vegetation Type within 100m & Direction from future dwellings	Average Slope of Land (degrees)	Separation Distance from Identified Vegetation	Bushfire Attack Level (BAL)	Construction Section
Lot 401	Open Forest to the east	Cross-slope	25 <35m	BAL-29	Sect 3 & 7 of AS3959 and Sect A3.7 of PBP Addendum Appendix 3
			35 <48m	BAL-19	
Lot 402	Open Forest to the east	Cross-slope	25 <35m	BAL-29	Sect 3 & 7 of AS3959 and Sect A3.7 of PBP Addendum Appendix 3
			35 <48m	BAL-19	
Lot 403	Open Forest to the east	Cross-slope	25 <35m	BAL-29	Sect 3 & 7 of AS3959 and Sect A3.7 of PBP Addendum Appendix 3
			35 <48m	BAL-19

Lot Number	Vegetation Type within 100m & Direction from future dwellings	Average Slope of Land (degrees)	Separation Distance from Identified Vegetation	Bushfire Attack Level (BAL)	Construction Section
Lot 404	Open Forest to the east	Cross-slope	25 <35m	BAL-29	Sect 3 & 7 of AS3959 and Sect A3.7 of PBP Addendum Appendix 3
			35 <48m	BAL-19	
Lot 405	Open Forest to the east	Cross-slope	25 <35m	BAL-29	Sect 3 & 7 of AS3959 and Sect A3.7 of PBP Addendum Appendix 3
			35 <48m	BAL-19	
Lot 406	Open Forest to the east	Cross-slope	25 <35m	BAL-29	Sect 3 & 7 of AS3959 and Sect A3.7 of PBP Addendum Appendix 3
			35 <48m	BAL-19	
Lot 407	Open Forest to the east	Cross-slope	25 <35m	BAL-29	Sect 3 & 7 of AS3959 and Sect A3.7 of PBP Addendum Appendix 3
			35 <48m	BAL-19	
Lot 408	Open Forest to the east	Cross-slope	25 <35m	BAL-29	Sect 3 & 7 of AS3959 and Sect A3.7 of PBP Addendum Appendix 3
			35 <48m	BAL-19	
Lot 409	Open Forest to the east	Cross-slope	25 <35m	BAL-29	Sect 3 & 7 of AS3959 and Sect A3.7 of PBP Addendum Appendix 3

35 <48m	BAL-19

This report and mapping are not to be used to place wholesale restrictions on lots reflecting the resulting BAL mapping presented within. Building location and design will influence the application of the required BALs. For example, a lot indicated as being

affected by BAL-29 may have those facades that are not exposed to the bushfire threat constructed to a lower BAL (i.e. BAL-19), reducing the costs of construction and providing more flexibility in choice of external building materials.
