# **BUSHFIRE ATTACK LEVEL**

FOR
FUTURE DWELLINGS
AT
STAGE 3
BRUSH CREEK
EDGEWORTH
NSW 2285

## Firebird ecoSultants Pty Ltd

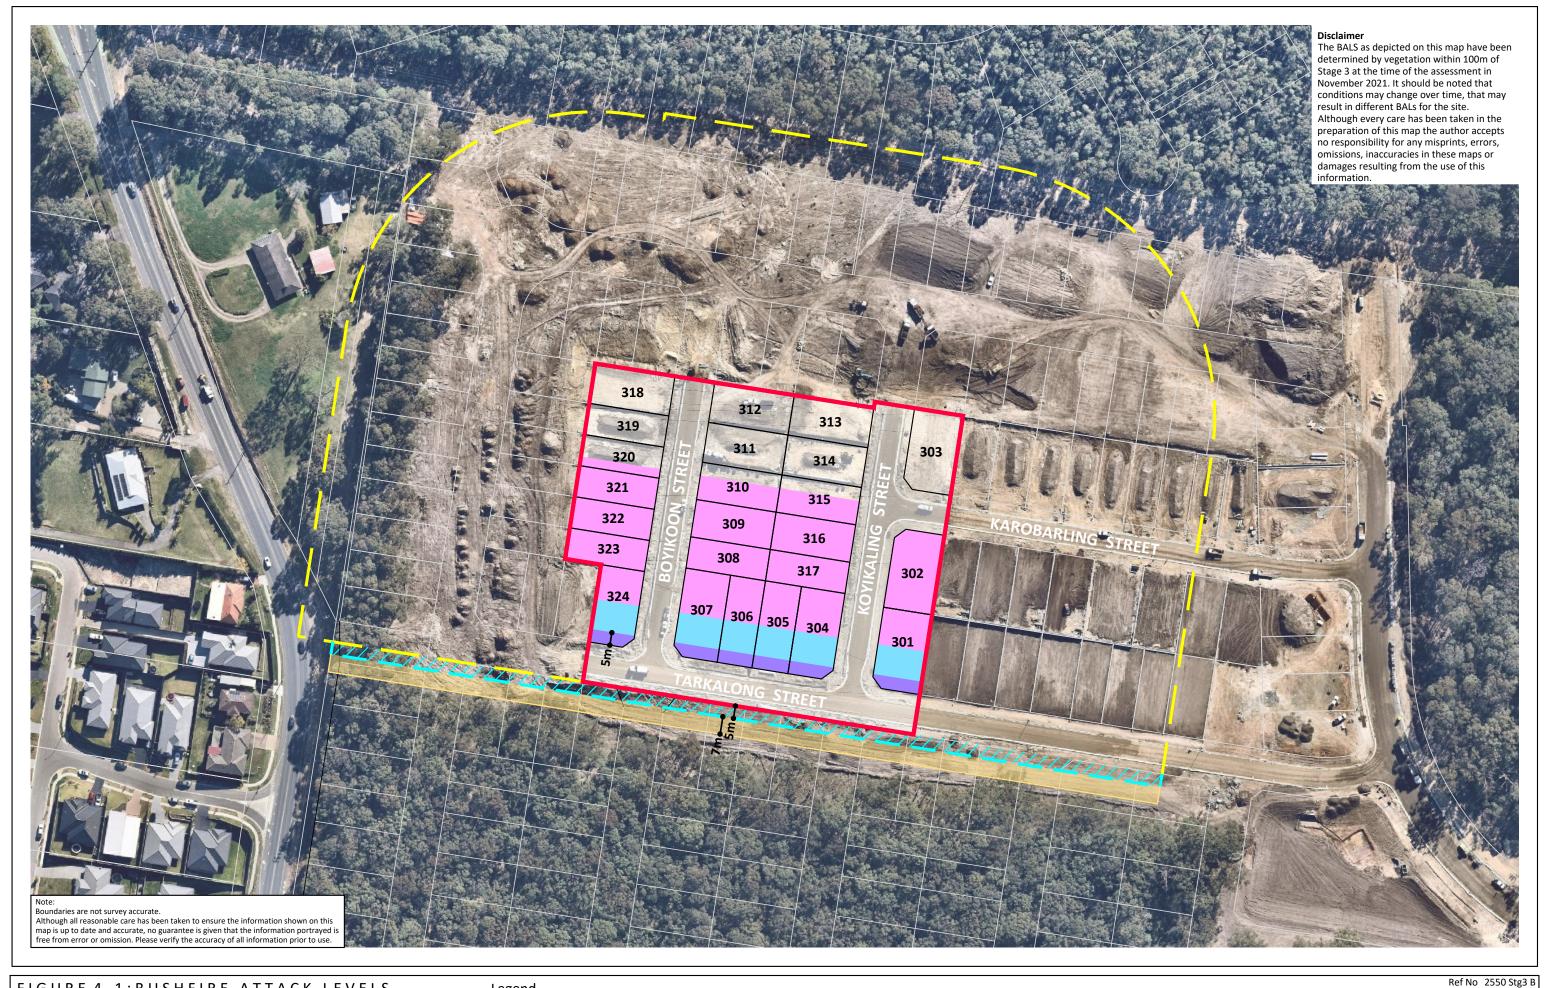
FIGURE 4-1:BUSHFIRE ATTACK LEVELS

The results from this bush fire attack assessment are detailed below in Table 4-1–Bushfire Attack Level (BAL) Assessment and Figure 4-1 Bushfire Attack Level Map.

This report and mapping are not to be used to place wholesale restrictions on lots reflecting the resulting BAL mapping presented within. Building location and design will influence the application of the required BALs. For example, a lot indicated as being affected by BAL-29 may have those facades that are not exposed to the bushfire threat constructed to a lower BAL (i.e. BAL-19), reducing the costs of construction and providing more flexibility in choice of external building materials. Refer to Appendix B for Summary of AS3959-2018 Construction Standards and Appendix C for Additional Building Requirements.
